Manhole Inspection Summary

Manhole # S37U__032MH

Location Address: **alley in rear of 1518 William Street** Cross Street: **E. Fort Avenue**

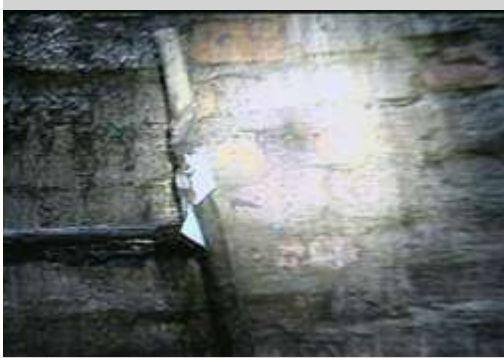
Defect 2

Steps Count: **4** Missing: **1** ☒ **Corroded**

corroded step

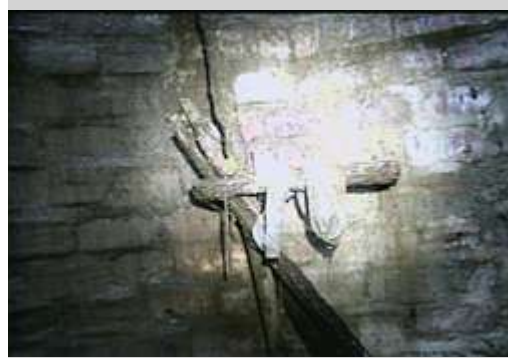
Defect 1

Surcharge ☒ **Evidence Of Surcharge** Depth: **2** (ft.) ☐ Active Surcharge Present

evidence of surcharge

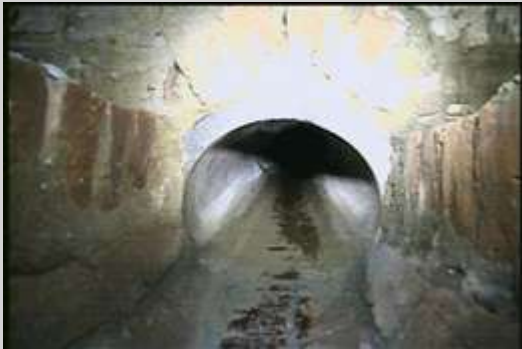
12 O'Clock Outflow

8 in. Circular Gravity Sewer
Pipe Out @ 12 O'Clock

Pipe Material: **Clay** ☐ Pipe Lined

Invert Depth: **8.20** (ft.) Flow Characteristics: **Slow**

Deposits: ☒ None ☐ Mud ☐ Sludge ☐ Debris ☐ Grease

Infiltration: **None** Pipe Seal Cond: **Unknown**

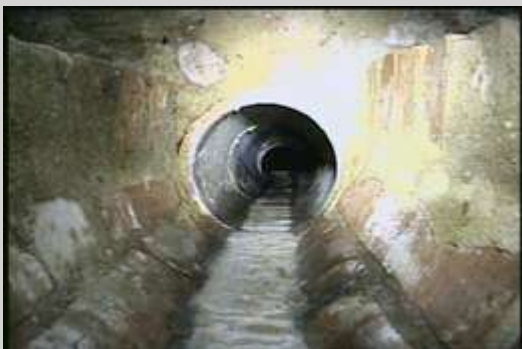
5 O'Clock Inflow

8 in. Circular Gravity Sewer
Pipe In @ 5 O'Clock

Pipe Material: **Clay** ☐ Pipe Lined

Invert Depth: **8.00** (ft.) Flow Characteristics: **Slow**

Deposits: ☒ None ☐ Mud ☐ Sludge ☐ Debris ☐ Grease

Infiltration: **None** Pipe Seal Cond: **Unknown**

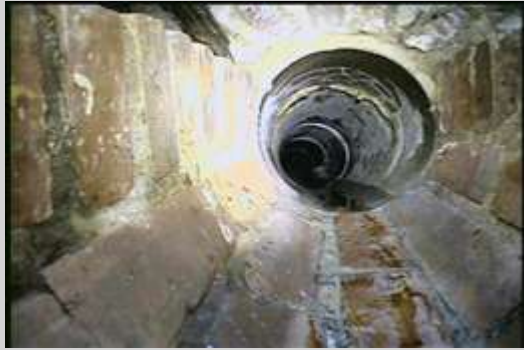
8 O'Clock Inflow

6 in. Circular Gravity Sewer
Pipe In @ 8 O'Clock

Pipe Material: **Clay** ☐ Pipe Lined

Invert Depth: **8.00** (ft.) Flow Characteristics: **None**

Deposits: ☒ None ☐ Mud ☐ Sludge ☐ Debris ☐ Grease

Infiltration: **None**
